History and Preservation of Daytona Beach's Unique Coquina Clock Tower

By Randy Jaye (FL)

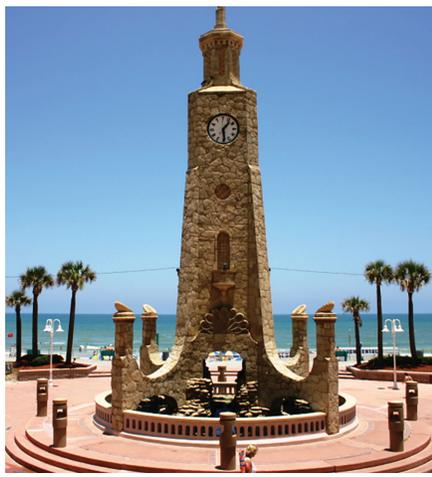
Figure 1. The Daytona Beach Coquina Clock Tower (photographed by Randy Jaye on June 23, 2007) was missing its original weather vane at this time (it was lost along with pieces of the spire in the late 1970s during a strong tropical storm).

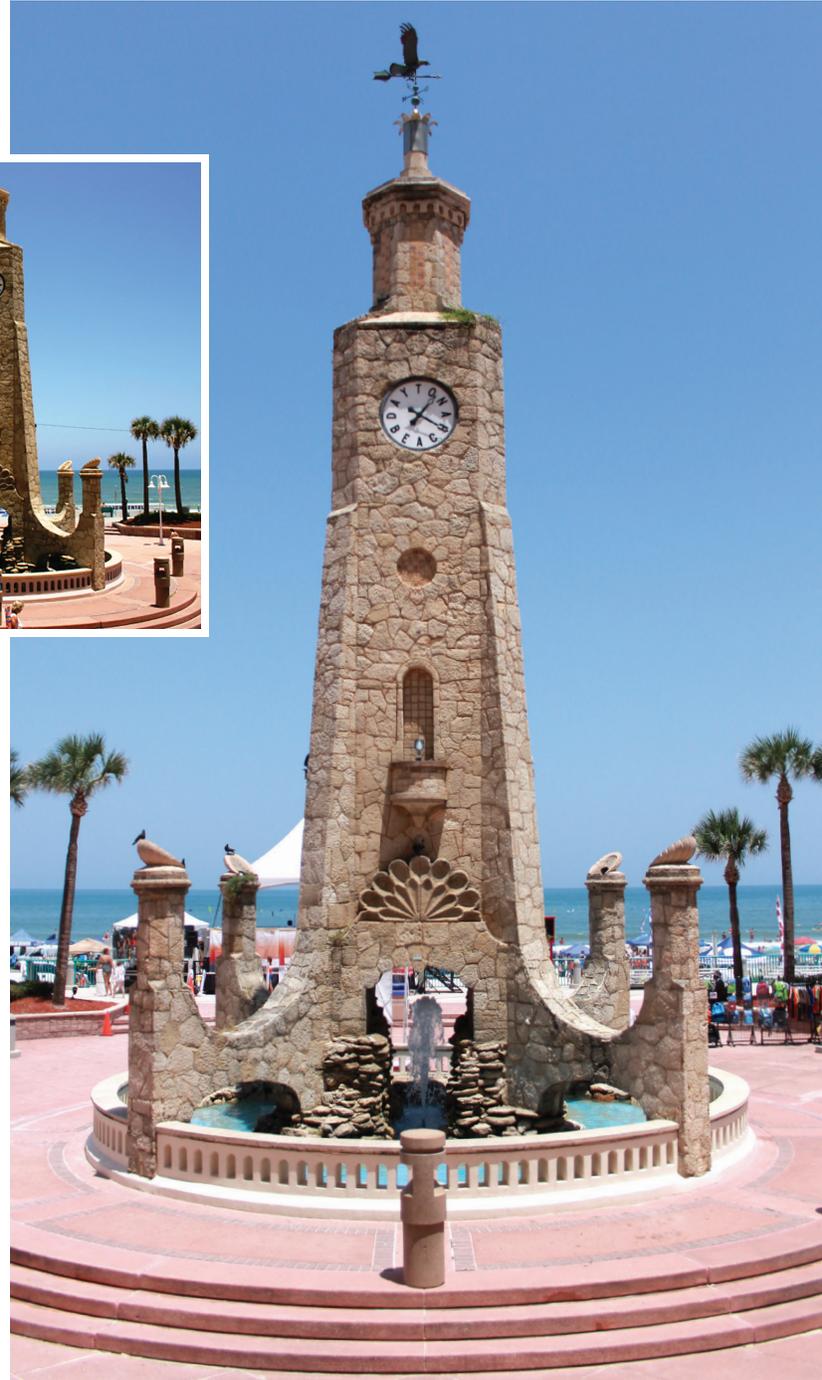
Figure 2. The clock tower (photographed by Randy Jaye on August 5, 2015) had a non-original petal base (stainless steel base cap) with decorative petals and a non-original but period-correct, copper-sheathed eagle weather vane.

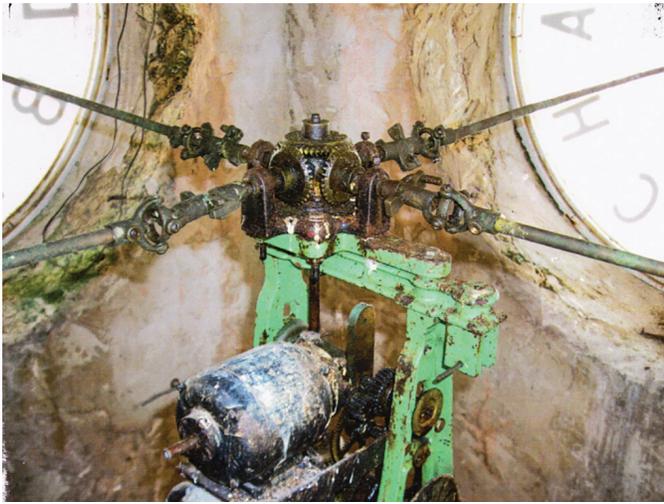
The original mid-1930s clockworks were a Seth Thomas Clock Co. 8-day timepiece, Model No. 4-1912 tower clock movement with serial number 3180 (Figure 3). This movement had a pendulum that was four feet long and a pendulum ball that weighed 28 lb. It featured a power wind mechanism with a mercury switch that included a power reserve of two to three hours. When the weights dropped to a fixed distance the mercury switch was triggered, which then activated the power wind mechanism to automatically rewind the weights. The movement was eventually converted to a full electric motor-driven mechanism (electrified) in the 1980s.

Figure 3. Original Seth Thomas movement with the electric motor running in the clock room. PHOTO COURTESY OF TOM BRANSFORD AND CHAPTER 154.

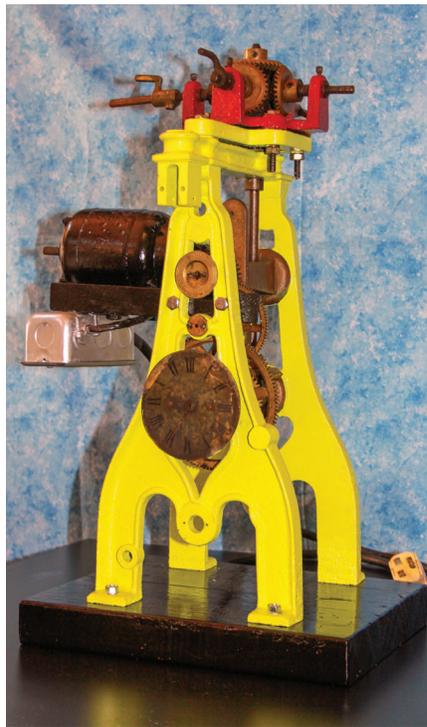
Figure 8. Original 1930s Seth Thomas movement (with the electric motor and cords that were added in the 1980s) now on display at the Halifax Historical Museum. PHOTOGRAPHED BY RANDY JAYE ON AUGUST 5, 2015.

To remove the clockworks, the original hour and minute hands had to be sawed off due to corrosion and wear. The original clock movement and its added electrical works were cosmetically refurbished and are currently on display in the Halifax Historical Museum (Figure 8).

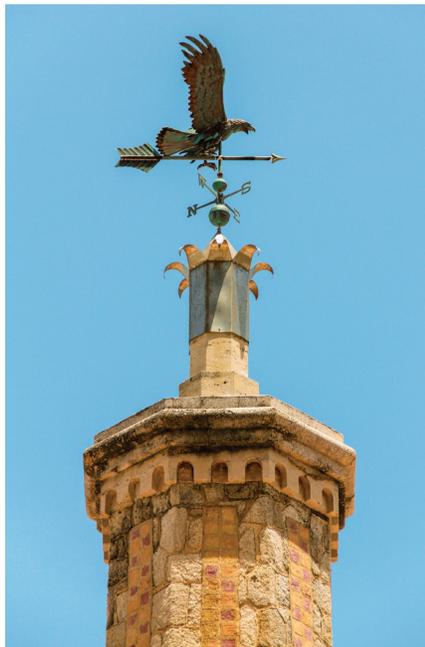
Figure 9. Stainless steel base cap with decorative petals and weather vane. Photographed by Randy Jaye on August 5, 2015. (Note: This stainless steel cap was removed in March 2016 when a period-correct concrete Spire was constructed.)

In October 2013, city crews built a custom, stainless-steel base cap with decorative petals in preparation for a new weather vane installation. On November 7, 2013, the base cap and the new weather vane (Figure 9) were installed on top of Daytona Beach's Coquina Clock Tower. The new copper-sheathed eagle was period-correct and looks very close to the original, which was lost in the late 1970s during a tropical storm. It weighed 130 lb. and was made by Weathervanes of Maine.¹⁸ This weather vane cost \$1,400 and took city crews two hours to install. Local donations of more than \$1,000 assisted with replacement costs.

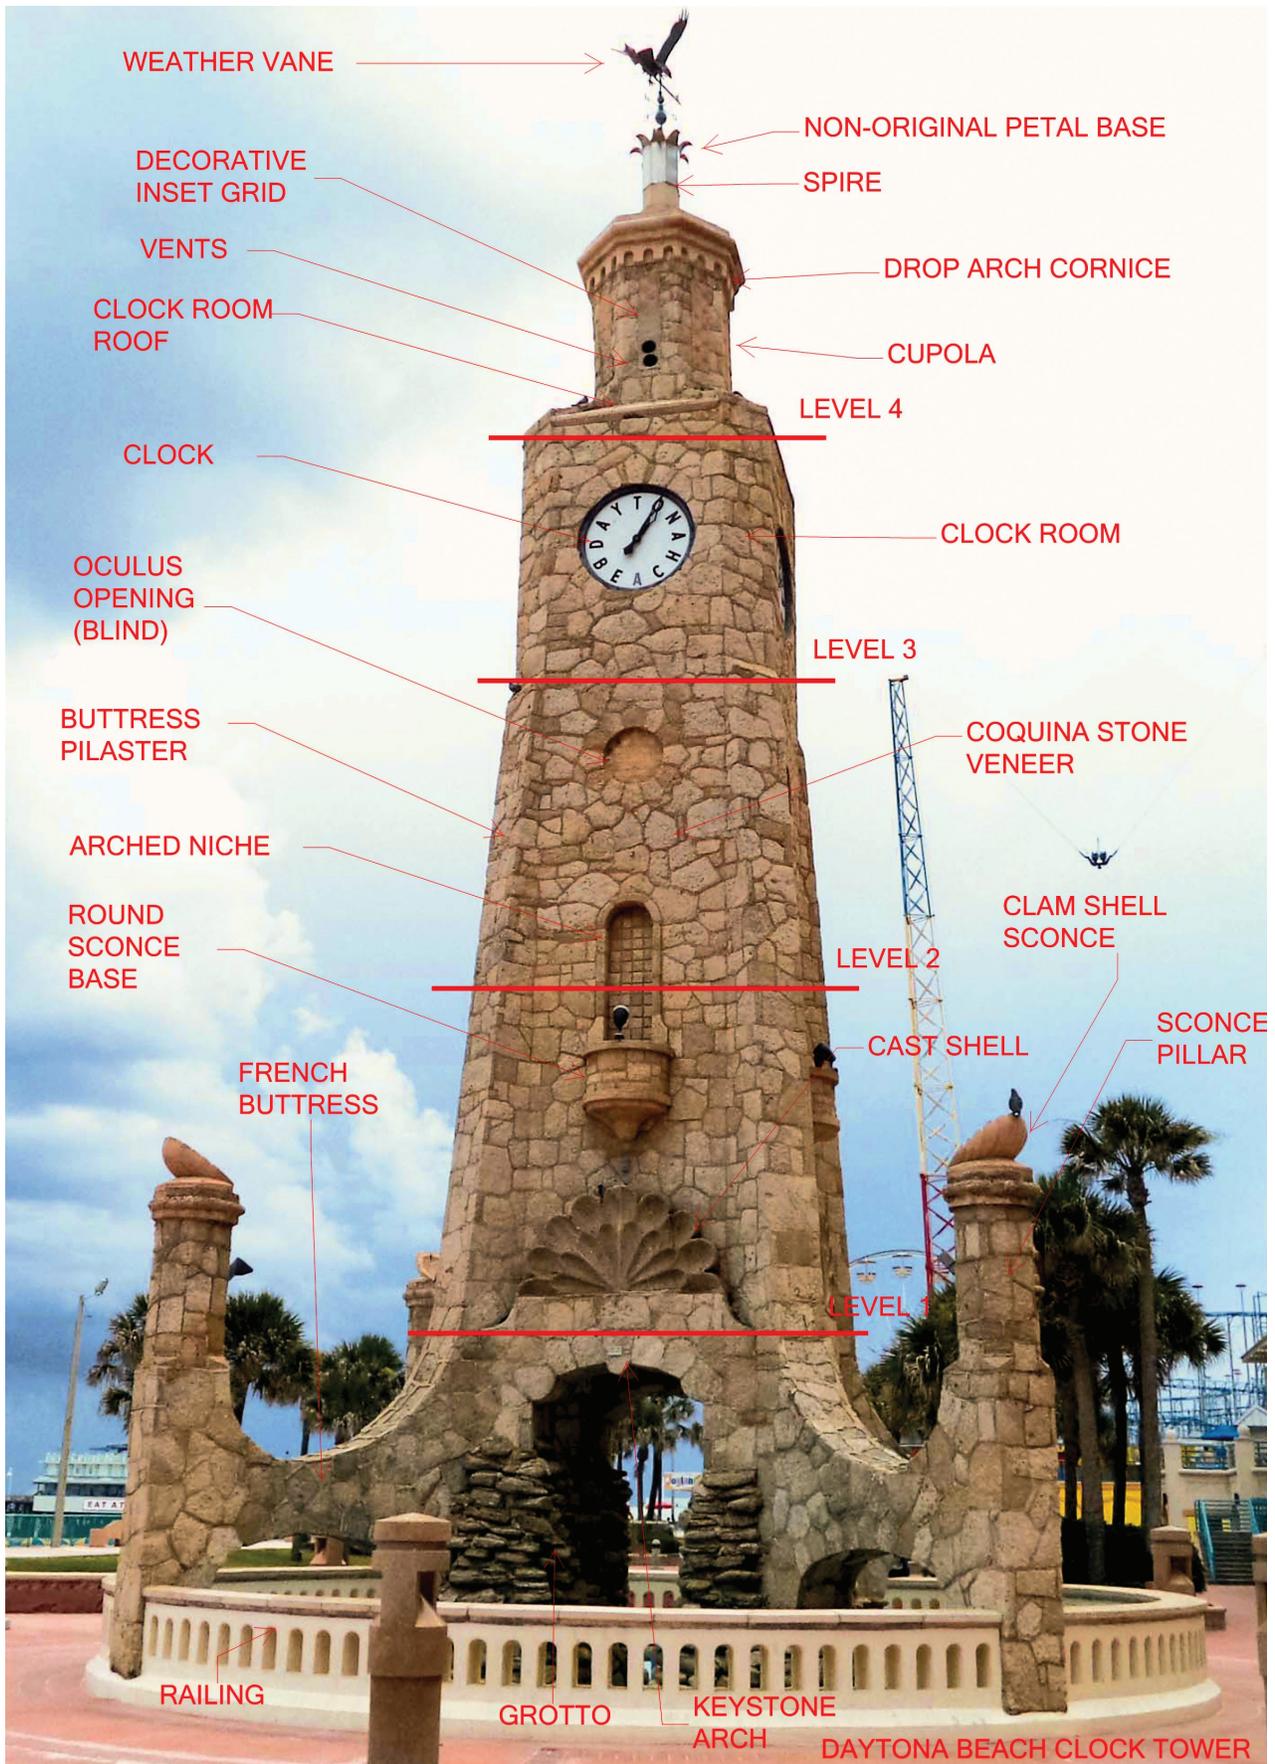
The Renker-Eich-Parks Architects¹⁹ firm was hired by the city of Daytona Beach to inspect the clock tower and write a condition assessment report. This report includes sections on physical condition assessment and preservation/restoration recommendations. A diagram (Figure 10) showing all the features of the clock tower was created by a firm architect, Paul C. Palmer, and provides an excellent reference. A summary of the condition states that the four French-style buttresses had some eroded coquina rock, there were several areas that required new mortar, and the entire structure required new, up-to-code electrical wiring.

Figure 10. Diagram created in 2014 identifies numerous architectural features. PHOTO COURTESY OF PAUL C. PALMER/RENKER-EICH-PARKS ARCHITECTS.

- Repoint deteriorated mortar joints
- Reset grotto coquina stone where missing
- Repair cast concrete sconce base
- Re-mortar joints at clock room roof
- Repair concrete at clock room roof
- Replace damaged/missing wood structure
- Treat algae inside cupola and clock room
- Replace rusting clock bracket fasteners
- Patch coat at clock openings
- Restore spire (discard the stainless-steel base cap with petals as it not historically correct)
- Weather vane: clean bird nests and perform general cleaning
- Structural: concrete repair at hatch floor
- Electrical: remove all existing electrical items from the structure and replace them with new lights, wiring, panels, receptacles, and controls

- Remove stainless-steel rods and hooks (patch holes)
- Paint stone checker pattern infills (red and yellow)
- Clockworks: replace clock-operating mechanisms and hands
- Provide new master clock controller, new timepieces with new hands (hands shall match historic originals from photographs and with review and approval from architect)
- Replace clock dials and exterior wood trim (ensure weather tight installation)

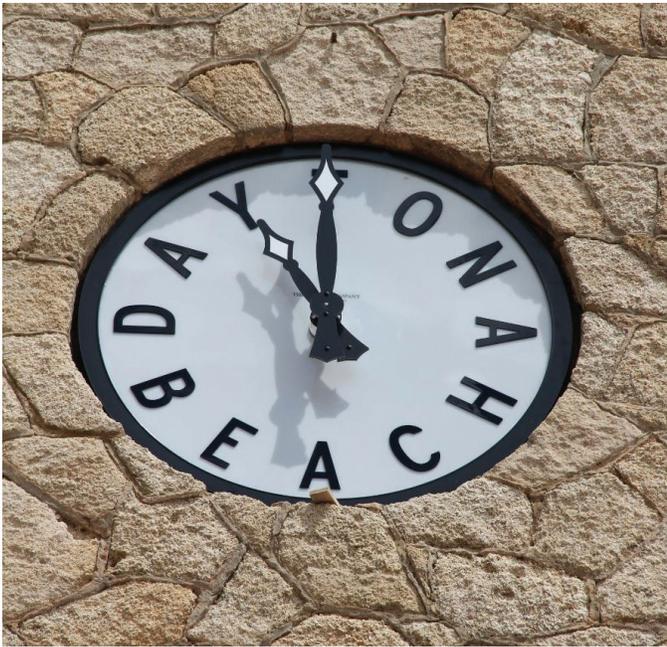
Figure 11. New dial and hands being installed. PHOTOGRAPHED BY RANDY JAYE ON JUNE 10, 2016.

Numerous new items have been installed and structural restoration has been completed. New custom dials and hands (Figure 11) were made by the Verdin Co. in their Cincinnati, OH, plant. The dials are made from $\frac{3}{8}$ " thick translucent acrylic sheet and the letters are made from $\frac{1}{8}$ " thick black acrylic. The hands are made from an aluminum composite material and finished with automotive-grade acrylic urethane. The clock movements were replaced, which resulted in accurate time being displayed on all four dials.

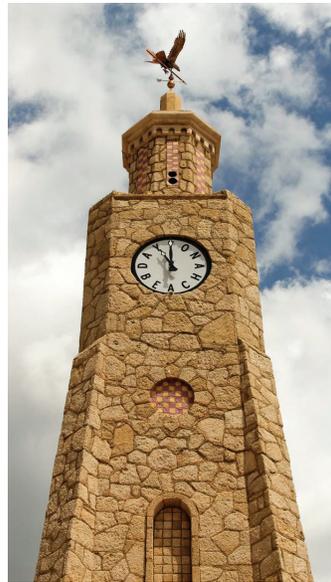
Figure 12. New concrete spire with the weather vane. PHOTOGRAPHED BY RANDY JAYE ON JUNE 10, 2016.

The non-original petal base was removed and the spire was reconstructed from concrete, which returned it to its period-correct condition. The weather vane was inserted back on top of the new concrete spire (Figures 12 and 13).

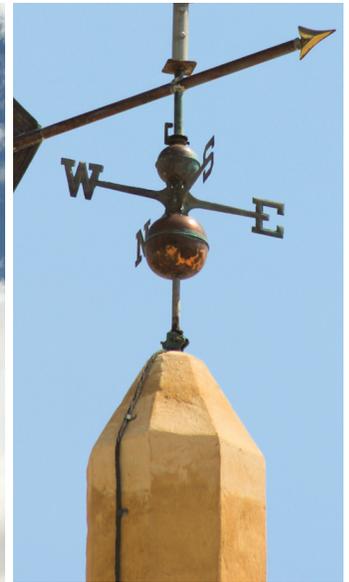
Figure 13. A new lightning rod was also installed. PHOTOGRAPHED BY RANDY JAYE ON JUNE 27, 2016.

protective rods have been installed on the tower. The fountain has been upgraded with a new motor and pump and it has been resurfaced as well.

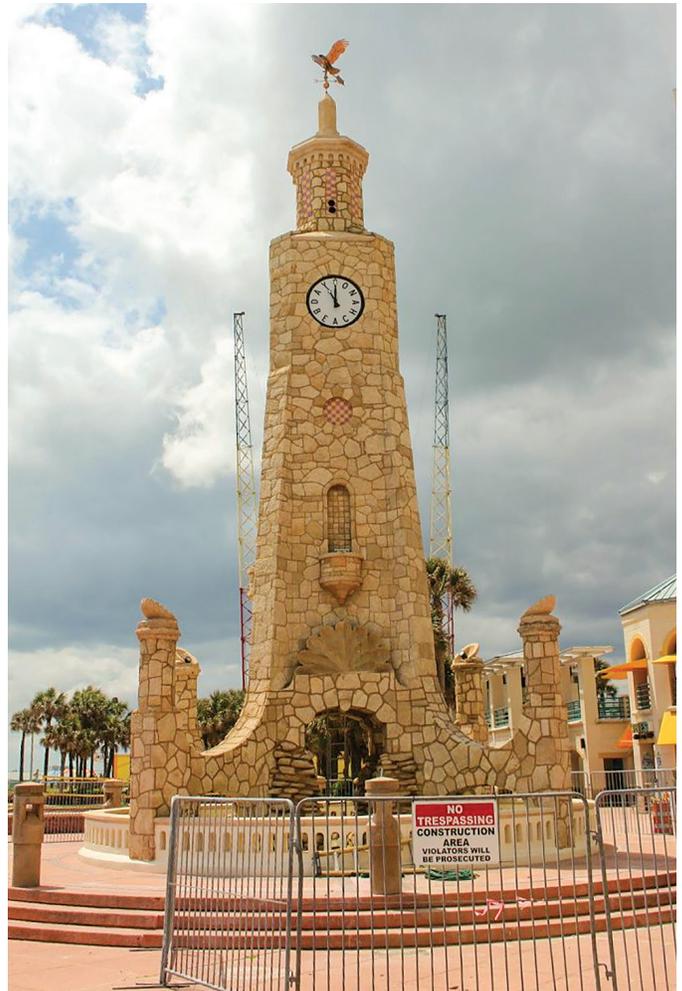
Figure 14. The restoration nearing completion. PHOTOGRAPHED BY RANDY JAYE ON JUNE 10, 2016.

The mortar joints have been repointed throughout the structure and the coquina rock pieces that were missing have been replaced. The blind oculus opening and the decorative inset grids on the cupola have been repainted (Figure 14).

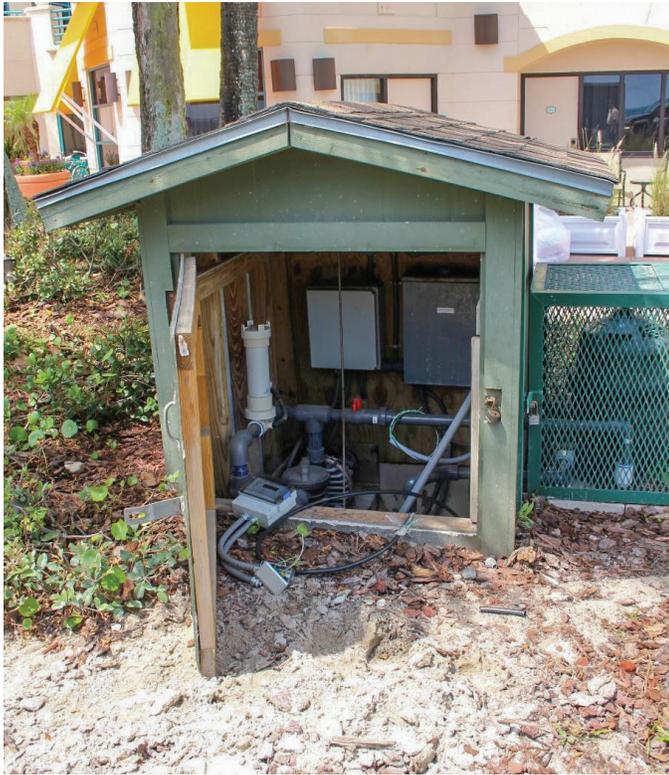
Figure 15. Clock tower pump house. New model MCCE Master Clock Controller being installed. PHOTOGRAPHED BY RANDY JAYE ON JUNE 10, 2016.

A new electrical clock movement has been installed. Additionally, a new remote-controlled master clock controller has been installed in the pump house (Figure 15), which eliminates manual resetting of the time. Former Daytona Beach Mayor Glenn Ritchey coordinated a donation of approximately \$4,500 to fund the master clock controller, its installation, and electrical components.

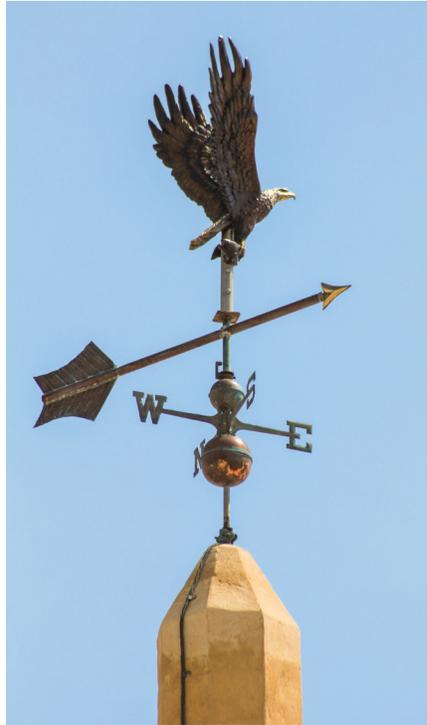
On October 7, 2016, less than four months after the completion of the rehabilitation project, Hurricane Matthew passed through the Daytona Beach area leaving a trail of destruction. As a result, the Daytona Beach Clock Tower sustained some damage, including the breaking of the north side dial and the loss of its new weather vane (which was blown off the tower and damaged beyond repair). The Verdin Co. made a new

Figure 17. Custom-made weather vane that was installed in April 2017. PHOTOGRAPHED BY RANDY JAYE ON MAY 22, 2017.

replacement dial and installed it in November 2016. The electric movements had been exposed to the elements when the dial was pushed in from its frame. Nevertheless, inspections determined that there was no damage to the electric movements or any of the electrical wiring or connections within the structure. The American Bronze Foundry, Inc.²⁵ of Sanford, FL, built a new custom weather vane (Figure 17), which was installed in April 2017.
